European Oak Expectations Briefing

This briefing document will cover off key elements that the user may notice when using the Oaken luminaire.

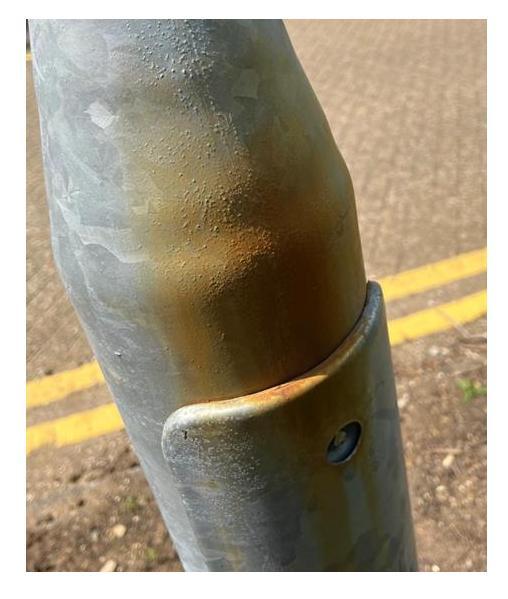
European Oak contains high levels of tannin, a natural water-soluble compound that leaches out as the timber is exposed to moisture, typically rainwater. Whether the Oak is freshly cut (green) or already dried, using it externally will cause tannin to wash out over time.

Tannin acts as a natural dye and can stain nearby materials such as brick, concrete, and paving. These stains typically appear as brown water marks and can spread wherever water from the timber flows. Although unsightly, the stains often fade over time as the tannins wash away. On some porous materials, however, light cleaning may be needed to fully remove any residual marks.

Fig.1 – Example Oak tannin (brown) stain on galvanised column

If immediate stain removal is required, treat the affected area with a solution of warm water mixed with oxalic acid. Spray the solution on the stain, allow it to sit briefly, then rinse with a hose or pressure washer.

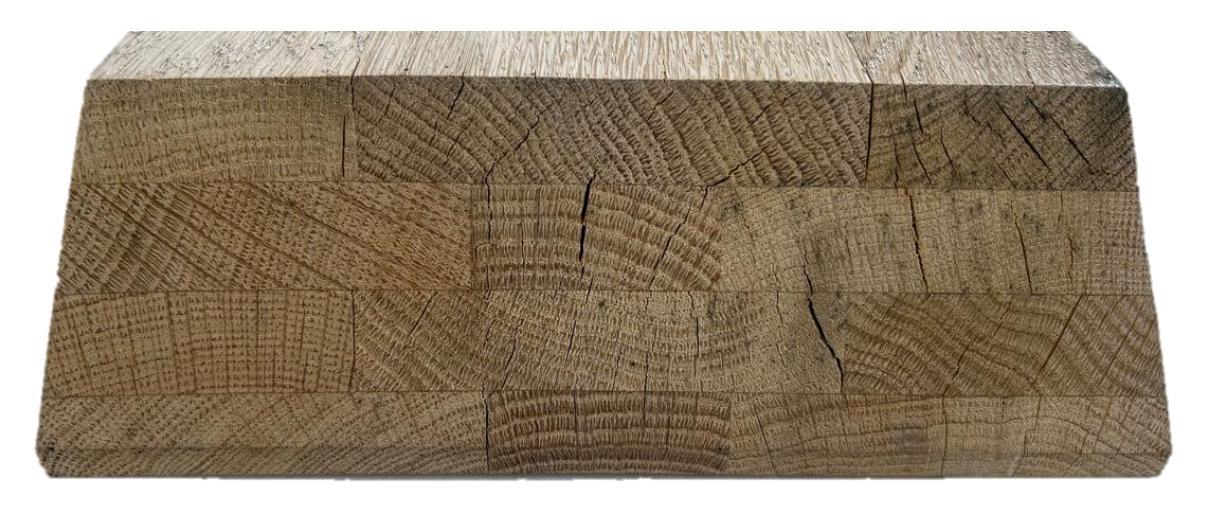
As the European Oak adjusts to its environment, you may observe small fissures or surface cracks developing. This is a completely normal and expected part of the wood's natural acclimatisation process. These fissures will occur due to humidity fluctuations, further drying and due to movement in service of the timber. As moisture evaporates from the timber, it causes slight shrinkage across the grain (rather than along it). This creates tension which leads to surface fissures. This is particularly prevalent at the end grain, where it is most susceptible to rapid moisture fluctuations.

It is important to understand that these fissures are superficial and do not indicate a fault or flaw in the wood. They are purely aesthetic and have no impact on the Oak's structural integrity, strength, or performance. In fact, this behaviour is so well understood in timber construction that we proactively design with it in mind, taking steps to minimize end grain exposure wherever possible such as orienting cuts strategically or using design details that protect the grain from excessive weathering.

Fig.2 – Expected end-grain fissures

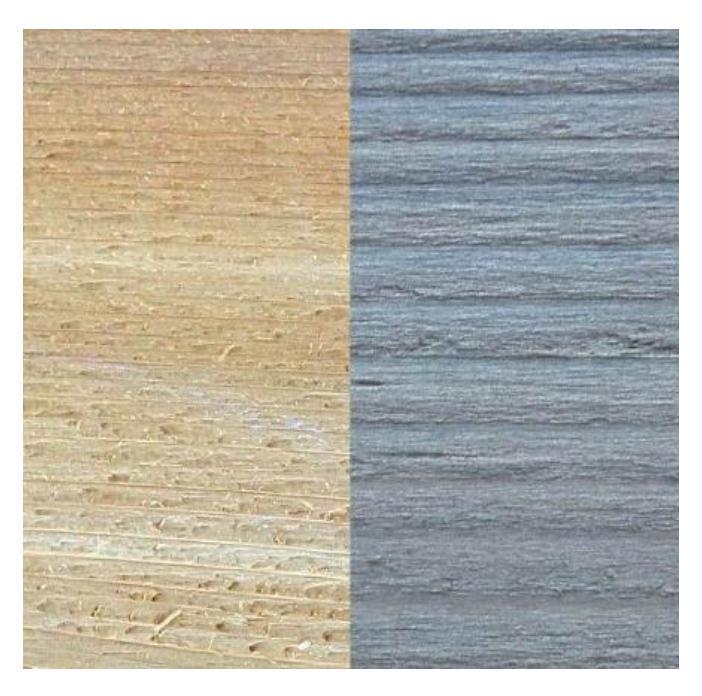
European Oak undergoes a natural and visually appealing ageing process when used outdoors. Initially, the timber has a warm, golden-brown or honey coloured appearance, showcasing its rich grain patterns and distinctive character. However, as the Oak is exposed to sunlight (UV rays), air, and moisture, over time its surface undergoes a transformation.

This weathering process causes the Oak to gradually fade to a silver-grey or silvery patina. This change is purely cosmetic and does not affect the wood's strength or durability. The speed of this transformation depends on environmental conditions such as sun exposure, rainfall, and wind. Areas with intense sunlight and frequent moisture will see the greying effect more quickly, sometimes within just 6–12 months.

Fig.3 - Initial warm natural colour vs. aged silver-grey colour
